OUR PEOPLE. ————— OUR STORIES.

Last week, **Utilities and Energy Management (UEM)** completed a repair on a leak in the water line that feeds Patterson Hall (left). The story of how we got to that point is a good one, and demonstrates the tremendous power of partnerships and collaboration. Shout out to **Keith Vorhoff** with Cenergestic for suggesting this as a story for the Newsletter

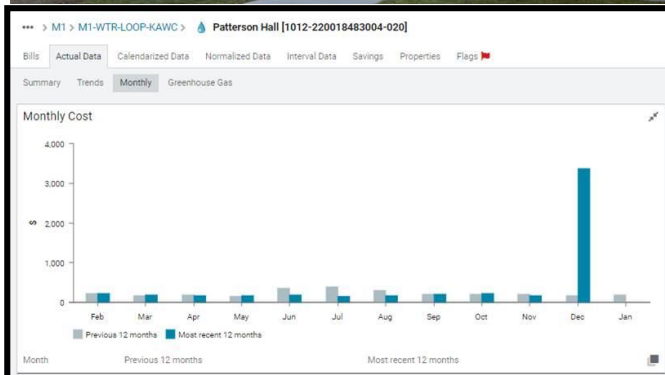
In January, our energy conservation partner Cenergestic, flagged Patterson Hall for a possible leak after noticing extremely high water use when entering that data into a software program we use to track utility usage (middle left). Their team investigated the meter, determined that the readings were accurate, and turned the issue over to the **Area 1 Maintenance Team**. The leak was substantial and caused our average cost per day for water/sewer for this building to jump from about \$9/day to more than \$300/day. Area 1 found no obvious leaks in the building. UEM scheduled a water outage for Patterson in coordination with **Kathy McKinley** and **UK Housing** to confirm if the leak was inside the building or outside. The outage test confirmed that the leak was somewhere along the approximately 250 feet of line between the meter and the building (bottom left).

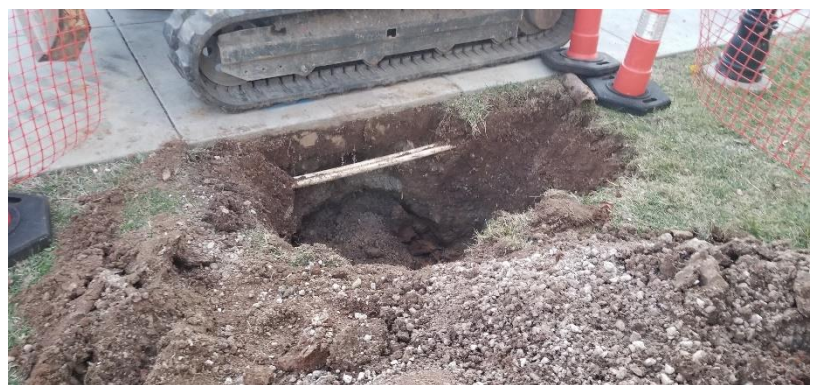
UEM's **Joe Graft** was very familiar with these lines and knew that finding the leak would be very difficult because the line was encased in gravel that would allow the water to flow away from the leak without coming to the surface. He recommended remote sensing be used to pinpoint the leak. **Eric Carroll** from UK ITS joined the effort and used Ground Penetrating Radar to accurately locate the leak. A contractor was then brought in to make the final repair (bottom right). **GREAT WORK TO EVERYONE INVOLVED!**
